CRASH LANDING

Crippled by flak over Germany, this Fort limped home and crash-landed in England. An AAF mobile repair unit fixed it on the spot.

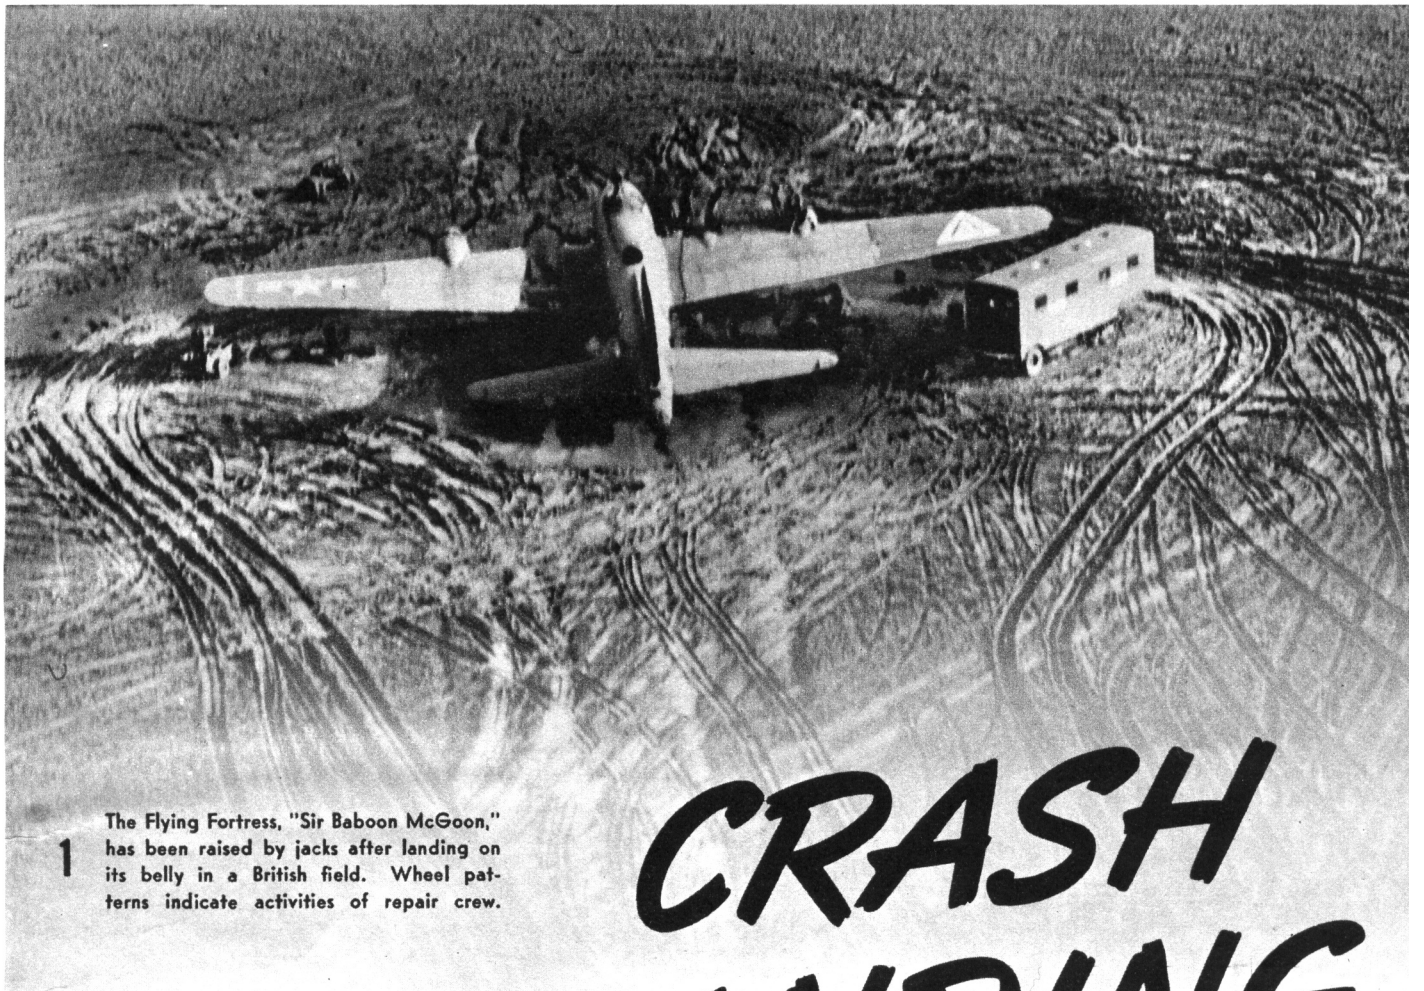
1

The Flying Fortress, "Sir Baboon McGoon," has been raised by jacks after landing on its belly in a British field. Wheel patterns indicate activities of repair crew.

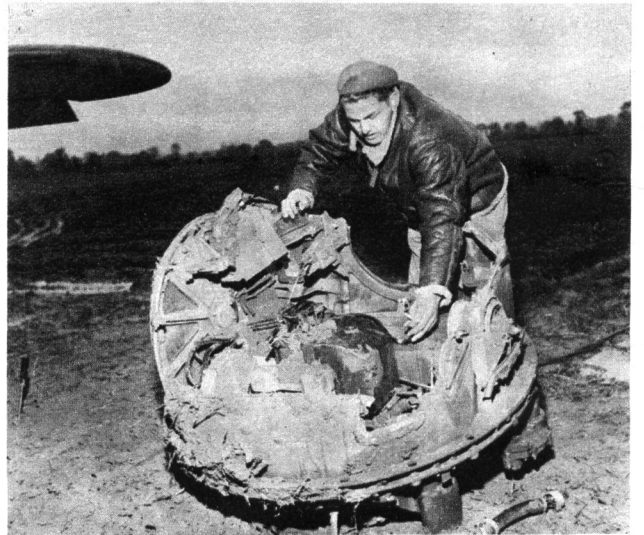
6 The belly turret bore brunt of the landing and sections of it shattered off on impact. The gunner was not in it.

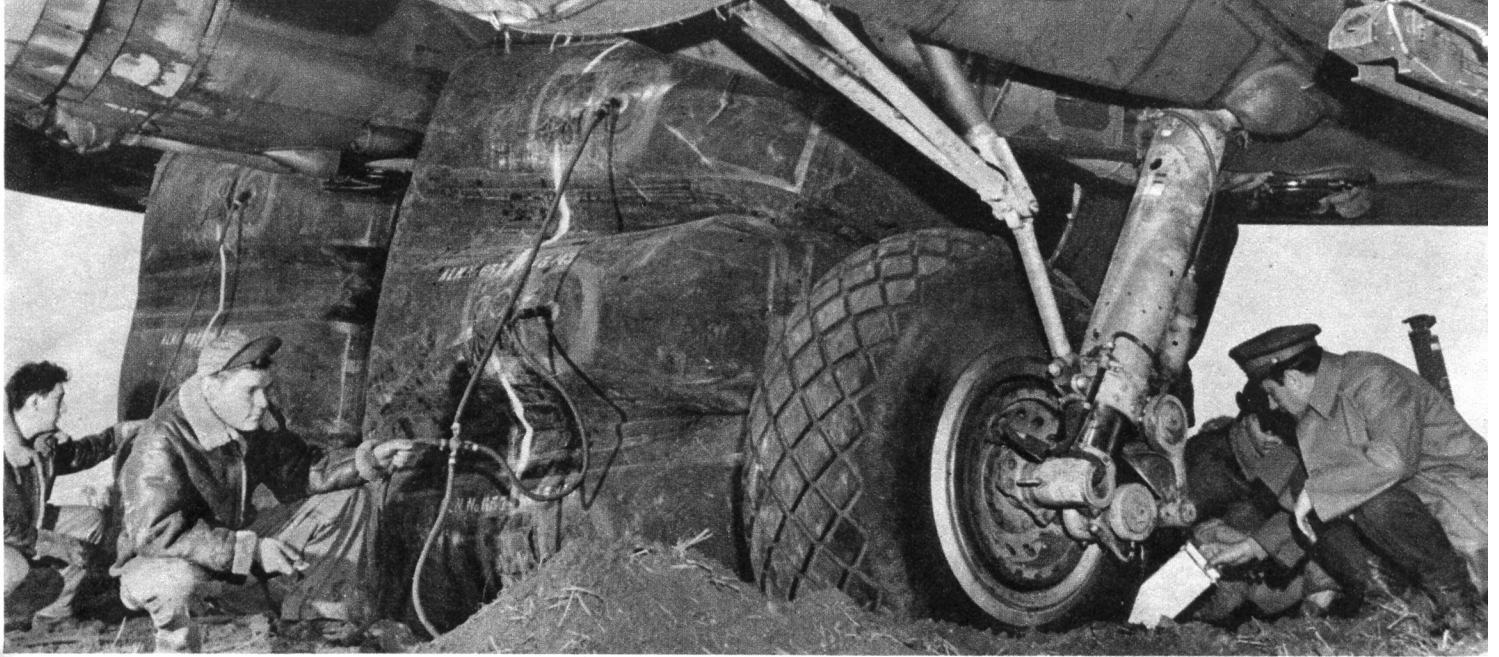
4 Huge balloon jacks, inserted flat between inboard engines and fuselage, raise Sir Baboon's 40,000-odd pounds easily. Wheels and other parts of plane's underside are checked carefully for damage. Note unusual bomb rack under wing close to fuselage.

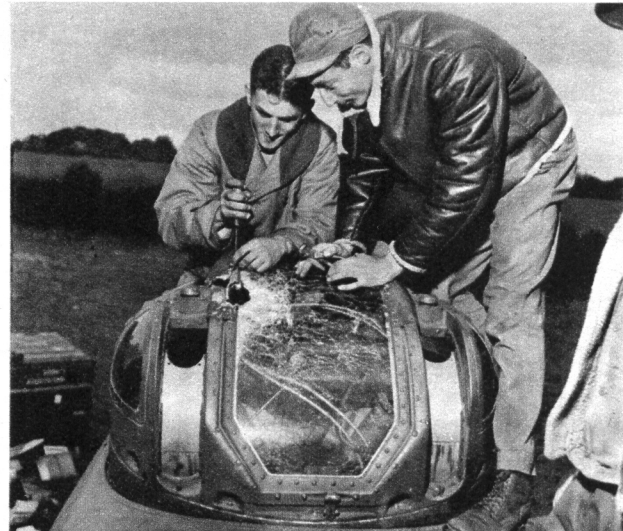
8 Damage to turret was result of a 20-mm. cannon hit by a Focke-Wulf Fw-190 during plane's mission over Germany.

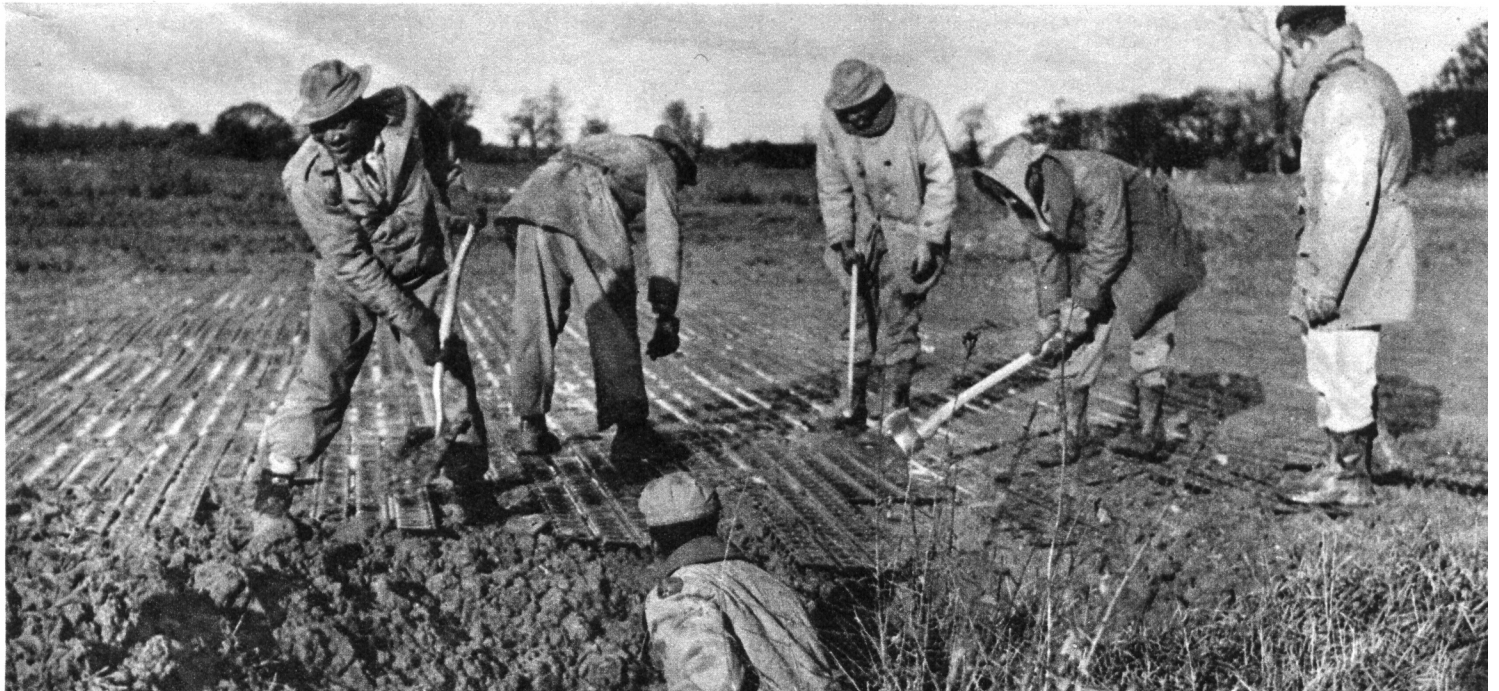
10 While repair job is under way, members of engineering unit level off ground, fill ditches and fix metal landing strips so that Fortress can take off when repairs are completed. Soft ground which enabled an easy landing would have endangered take-off.

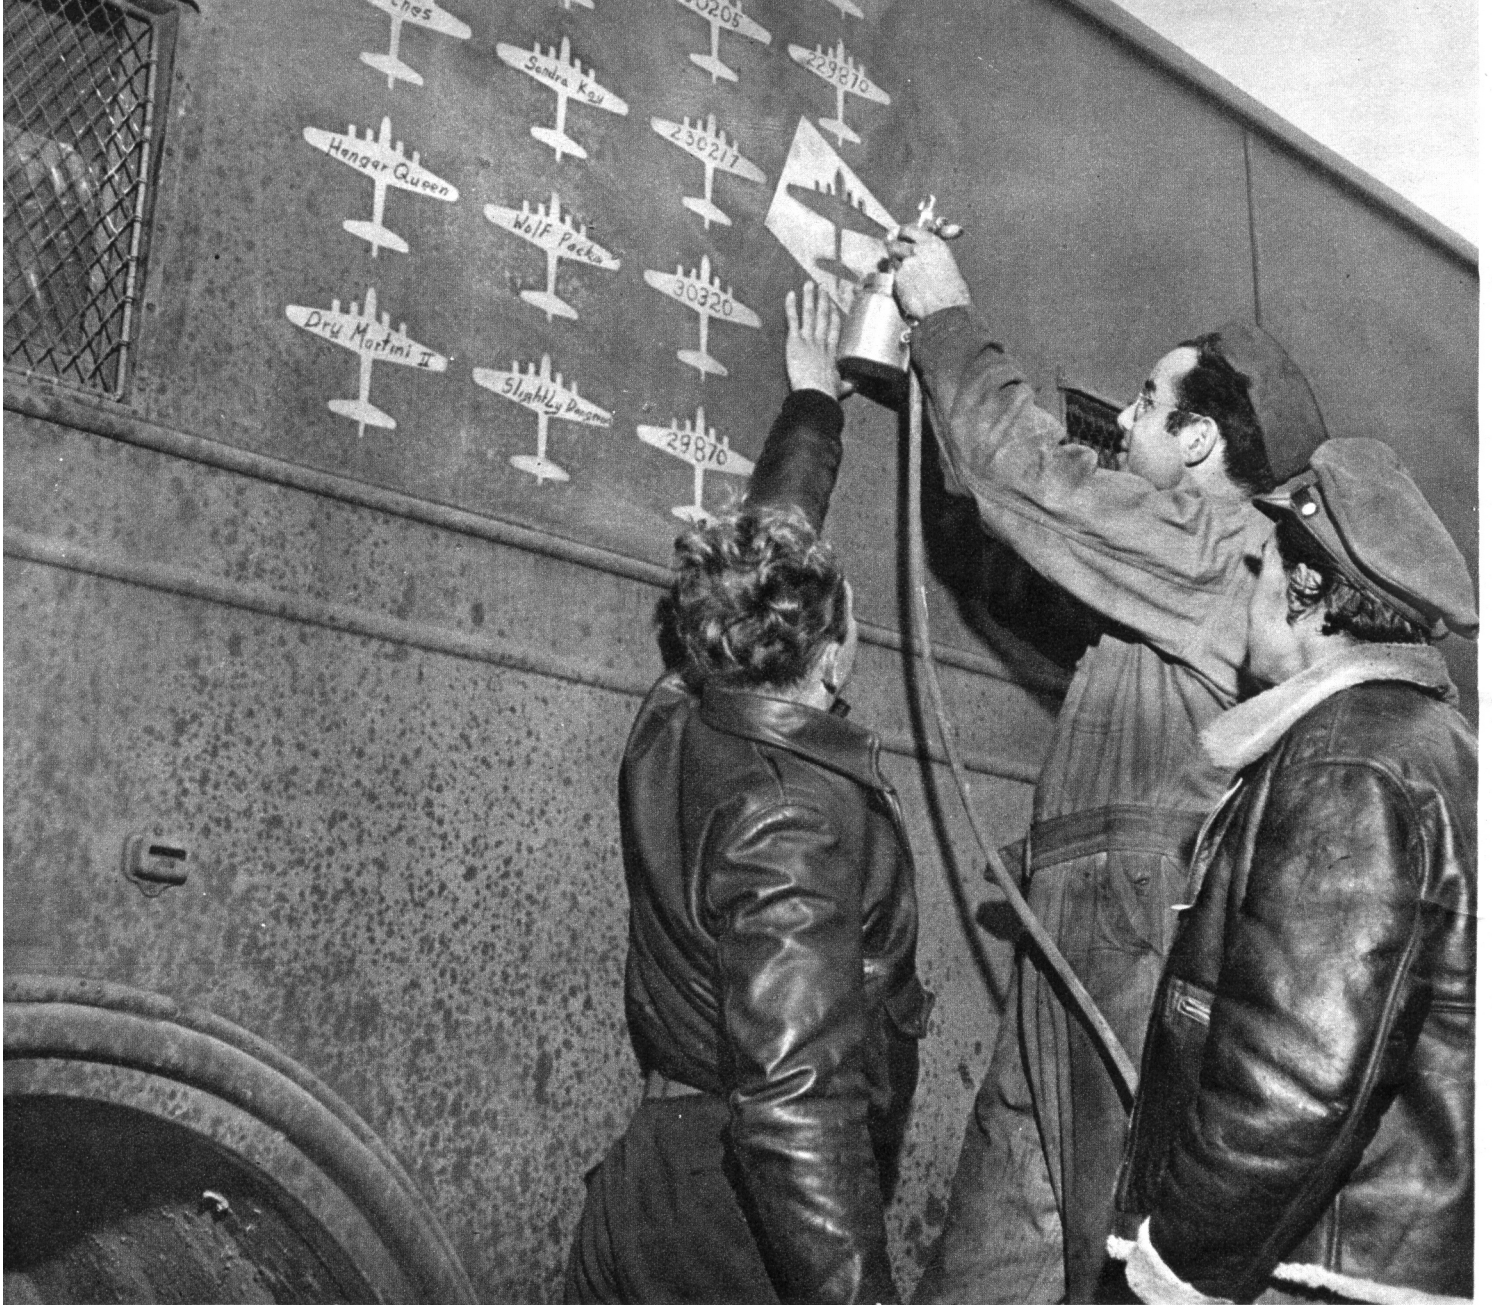
- 11** The job done, repair crew members stencil Fortress silhouette on side of their truck. Some of the bombers repaired by this crew include the Dry Martini II, Hangar Queen, Patches, and Sandra Kay. The numbers are AAF designations of unnamed Forts.
- 12** The Fort trundles down the metal landing strip, gathers speed and is airborne. The prompt action of Army Air Forces repair crews have enabled the AAF to keep additional hundreds of bombers in fighting trim for action against enemy war industry.
